Memorandum Report 1166

**CORROSION MECHANISMS IN STEAM POWER
GENERATION - A PROGRESS REPORT**

Consultant Staff - Corrosion
Metallurgy Division
U. S. Naval Research Laboratory
Washington 25, D. C.

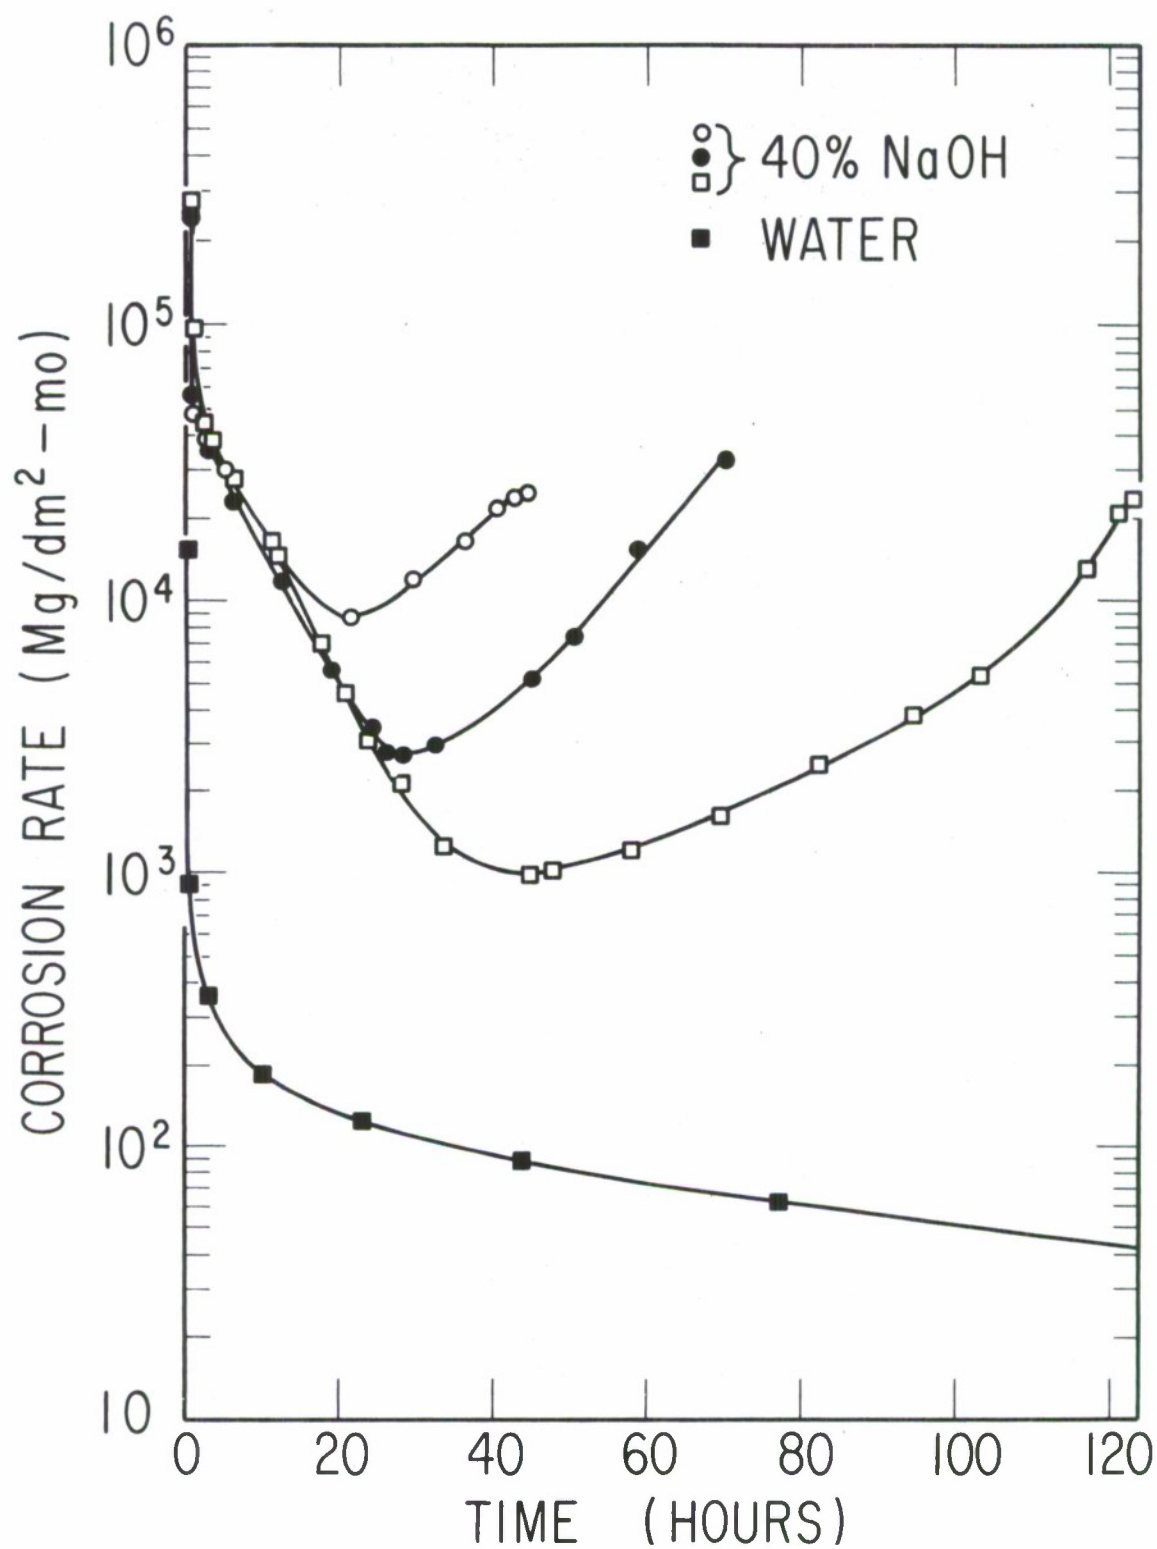
Fig. 1 - Corrosion rates of mild steel capsules containing water or 40% sodium hydroxide solution at 316°C

the ends of the capsules. During spot welding of the capsules martensite is formed at the capsule ends and the pitting attack occurred at the martensite-ferrite boundary or in the ferrite near the boundary, a region which was subjected to plastic deformation during fabrication and subsequent heating. The onset of the pitting attack coincided approximately with the end of the decrease in hydrogen effusion rates and the beginning of the rate increase. Figure 2 shows a section through one end of a capsule that was filled with 40% sodium hydroxide solution and removed from the oven after 24 hours, at a time when the rate was still decreasing.

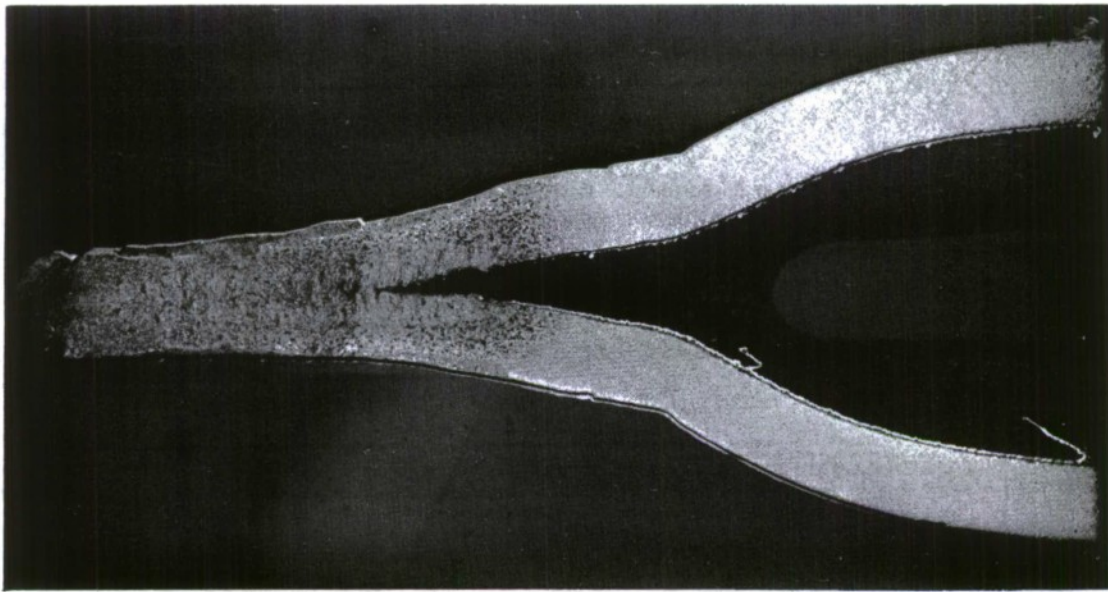
Fig. 2 - Section through end of mild steel capsule that was filled with 40% sodium hydroxide solution and treated at 316 °C (600 °F) for 24 hours. 1% Nital. Magnification: 15X. (Reduction in printing approximately 10%.)

This capsule, and also those shown in Figs. 3, 4 and 5, was silver-plated to provide a backing for holding the corrosion product in place during preparation for metallographic examination. The weld is at the left in Fig. 2, and the martensite, showing as the dark areas, is plainly visible. Although the catastrophic preferential attack has not yet begun in this capsule after 24 hours, it is readily seen in the 46-hour sample (Fig. 3), at which time the corrosion rate was increasing. The preferentially attacked sites on opposite walls of the capsule are plainly visible; pits were filled with corrosion product. Numerous pits developed in the vicinity of the martensite-ferrite boundary, so that grooves approximately perpendicular to the plane of Fig. 3 were formed.

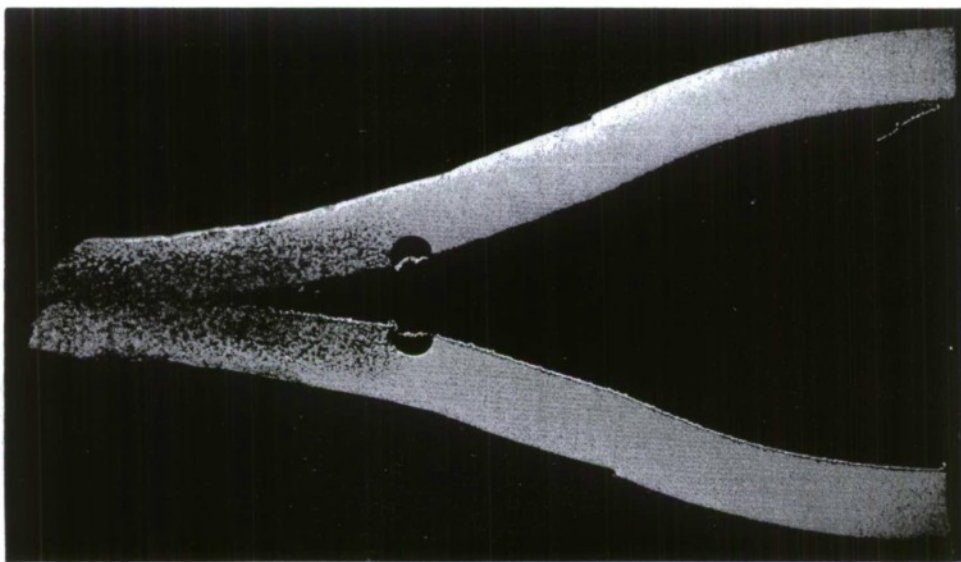
Fig. 3 - Section through end of mild steel capsule that was filled with 40% sodium hydroxide solution and treated at 316 °C (600 °F) for 46 hours. 1% Nital. Magnification: 15X. (Reduction in printing approximately 10%.)

Figure 4 shows one of the pits of Fig. 3 at higher magnification. The catastrophic attack seems to start at a point and proceed in all directions at approximately the same rate so that individual pits are approximately hemispheric in shape.

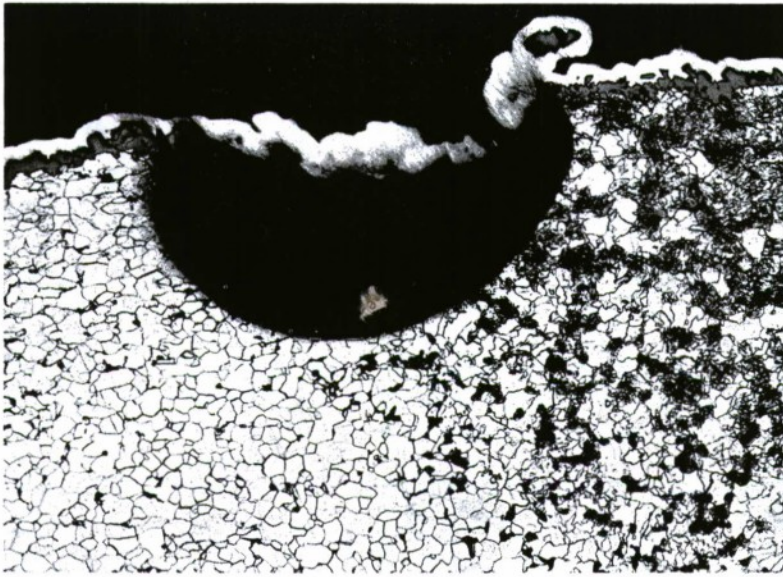
Fig. 4 - Magnified view of one of the pits shown in Fig. 3. 1% Nital. Magnification: 200X. (Reduction in printing approximately 35%.)

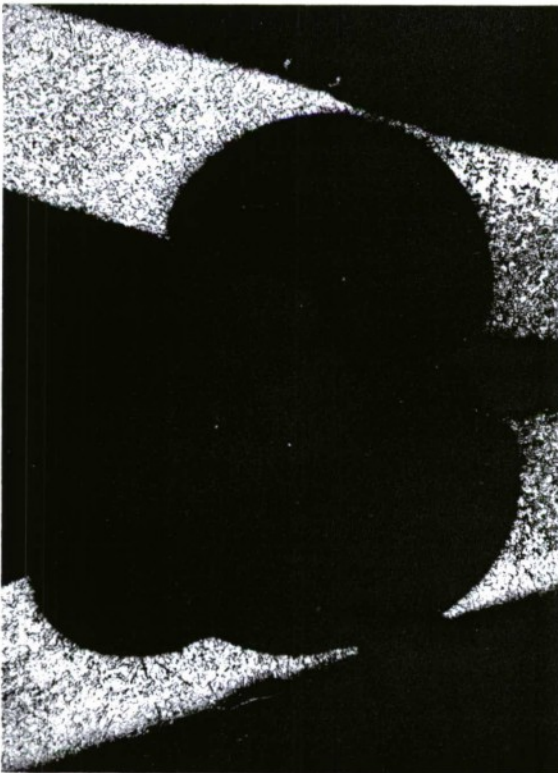
Fig.5 - Section near end of mild steel capsule that was filled with 40% sodium hydroxide solution. The capsule leaked after 51.6 hours at 316 °C (600 °F) and was immediately removed from the oven. 1% Nital. Magnification: 50X. (Reduction in printing approximately 35%.)

Figure 5 shows a section through opposite walls of a capsule near a welded end. The capsule wall at the bottom has been perforated, and the wall at the top is nearly perforated. The pits have smooth surfaces, the pitting attack showing no preference for grain boundaries or other physical features of the metal. This is in contrast to the general attack over most of the capsule surface, an example of which is shown in Fig. 6. Here the general corrosion proceeds on an irregular front, possibly showing some preference for grain boundaries. Magnetite was the only corrosion product found.

Figure 7 shows a typical pattern of the pitting observed in British high-pressure boilers (5). There is a striking similarity between this and Fig. 5.

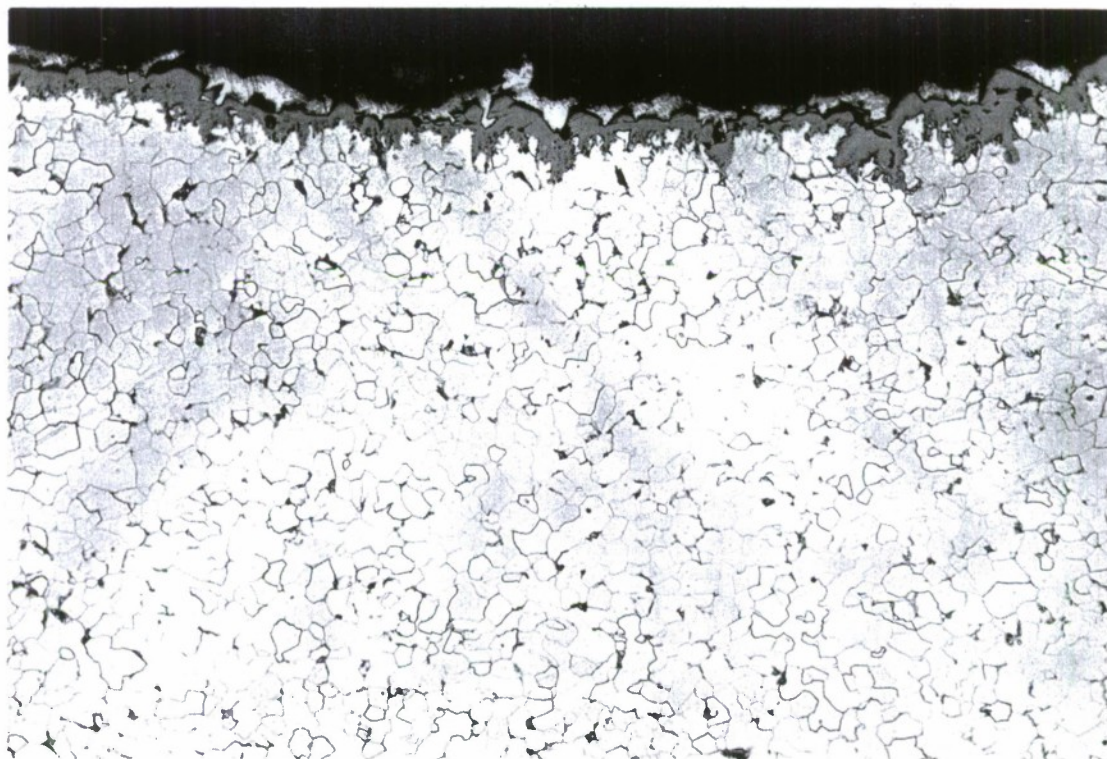
Fig. 6 - Section through inside surface of same capsule shown in Figs. 3 and 4 showing appearance of general corrosion over most of capsule surface. 1% Nital. Magnification: 200X. (Reduction in printing approximately 8%.)

In the case of the 40% NaOH it appears that a thick adherent continuous film of Fe_3O_4 is generated rapidly (Fig. 6) with much grain boundary penetration. Fe_3O_4 films are very good electronic conductors, and break down at some "weak spot" which exposes the unprotected steel is a favorable condition for pit development. The exposed spot constitutes a small anode, and the whole surface of the conductive Fe_3O_4 is available as a cathode in a highly conductive solution. Why it takes these high concentrations of caustic to cause breakdown at "weak spots" and what constitutes a "weak spot" is yet to be fully established. Present indications point to weld-heat-affected zones as one such spot.

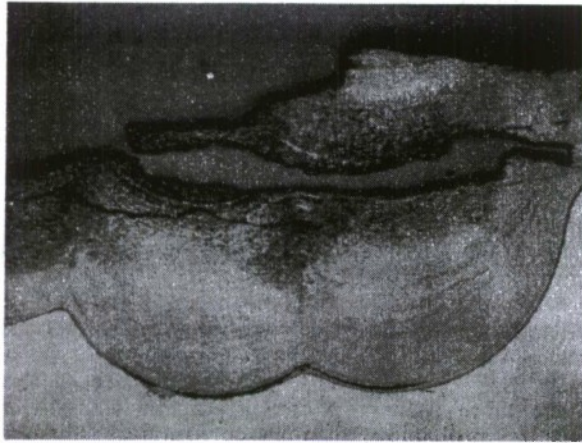
Fig.7 - Section through pit showing metal/magnetic oxide interface. Magnification: 10X. (From Ref. 5.)

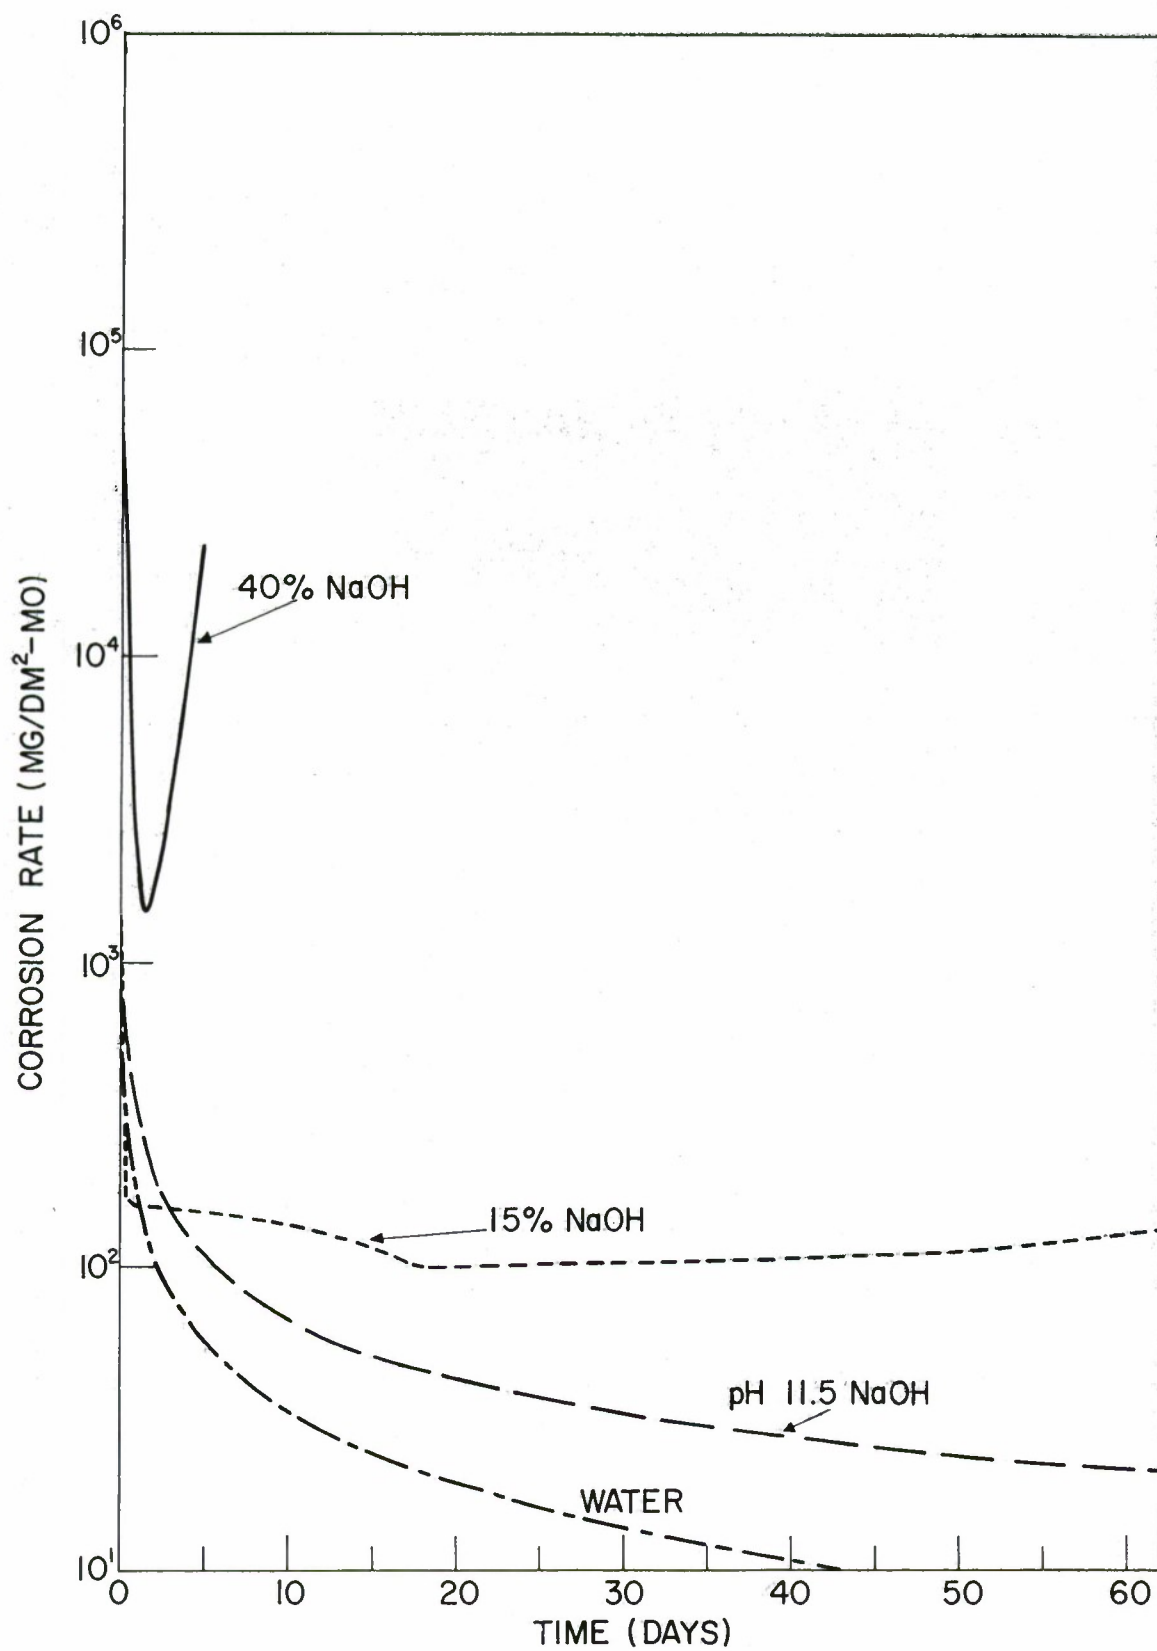
Fig. 8 - Corrosion rate of mild steel at 316°C (600°F).

The overall picture of corrosion rates in caustic solutions which has thus far been obtained is shown in Fig. 8.

Specimens corroded in 15% NaOH have not yet been examined microscopically. The significance of the upward trend in the corrosion rate after 20 days which is shown in Fig. 8 is not yet clear. It may be a concentration effect since water is used up in the reaction

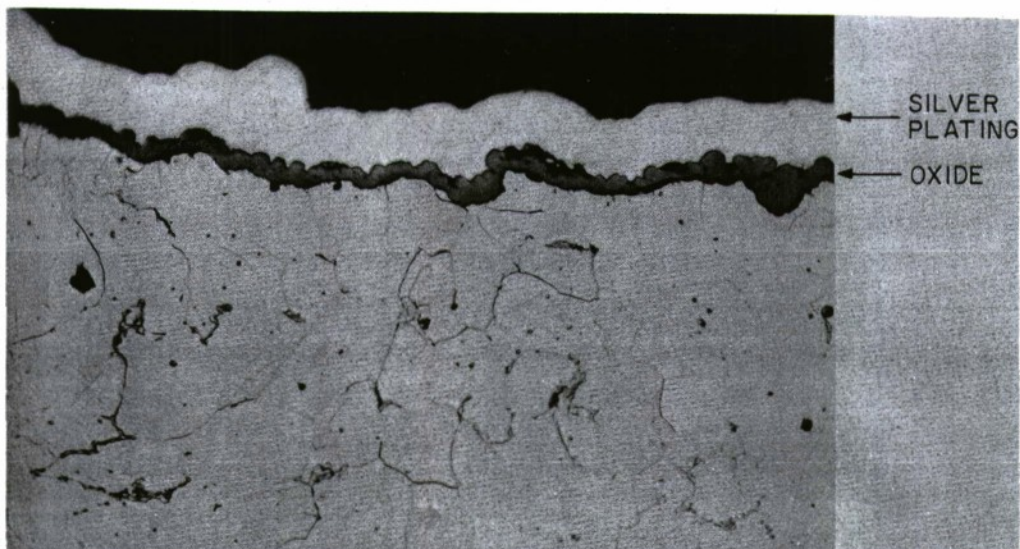
Fig. 9 - Section perpendicular to inside surface of mild steel capsule that was filled with water and treated at 316°C (600°F) for 789 days. Sample silver-plated before polishing. 1% Nital. Magnification: 1000X. (Reduction in printing approximately 35%.)

Some partial answers regarding what is happening to the protective film to cause these changes are indicated in Figs. 9-11. It may be noted that increase in pH is accompanied by a marked increase in the size of the crystals in the protective films. Thus, the surfaces of the films generated at pH of 10.6 and 11.5 show the sharp linear outline of cross sections of crystal faces whereas the surface of the film generated at a pH of 7 does not. The x-ray patterns obtained from the films generated at a pH of 7 showed line broadening, indicating that the major mass of this deposit has a crystallite size less than 1000 Å. It

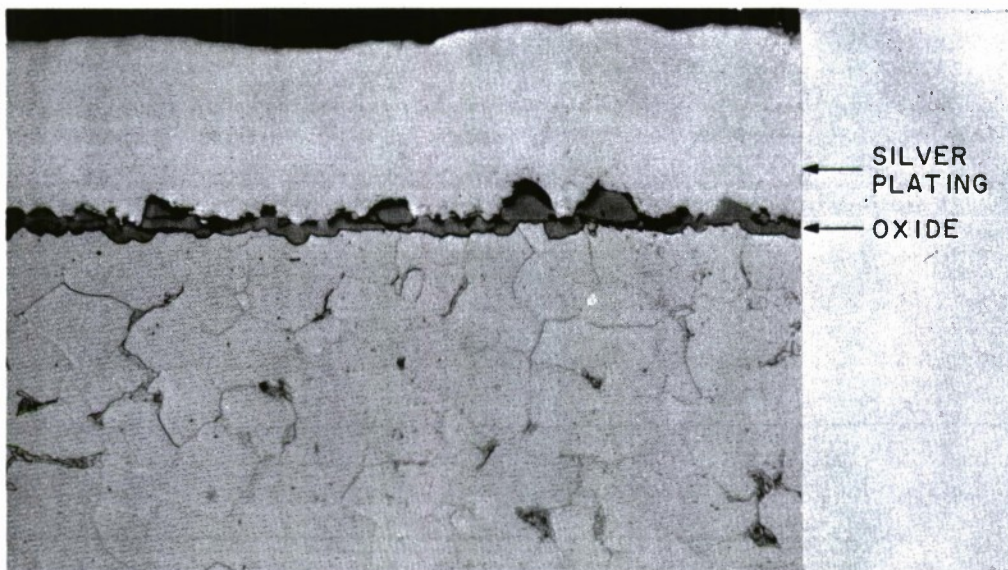
Fig. 10 - Section perpendicular to inside surface of mild steel capsule that was filled with pH 10.6 sodium hydroxide solution and treated at 316°C (600°F) for 439 days. Sample silver-plated before polishing. 1% Nital. Magnification: 1000X. (Reduction in printing approximately 35%.)

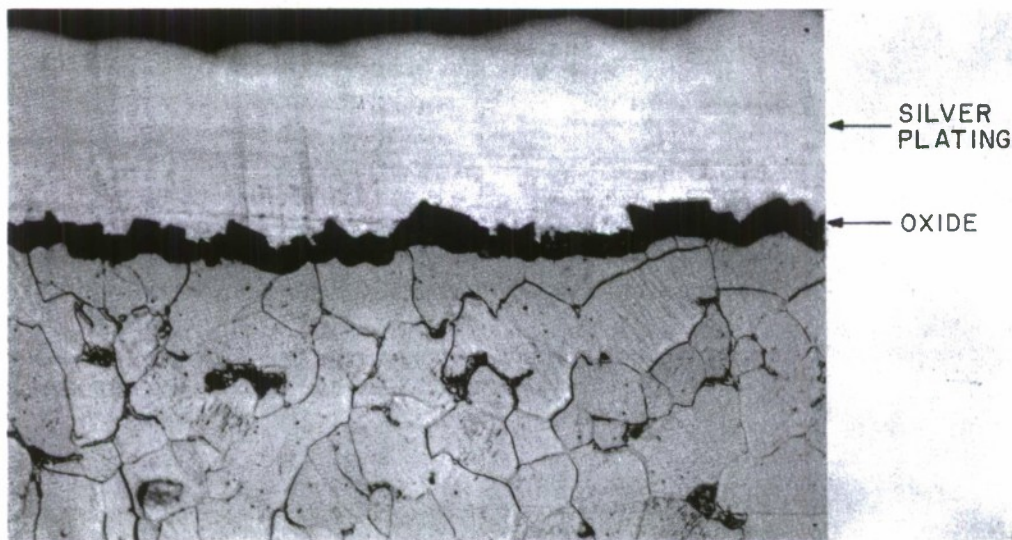
Fig. 11 - Section perpendicular to inside surface of mild steel capsule that was filled with pH 11.5 sodium hydroxide solution and treated at 316°C (600°F) for 283 days. Sample silver-plated before polishing. 1% Nital. Magnification: 1000X. (Reduction in printing approximately 35%.)

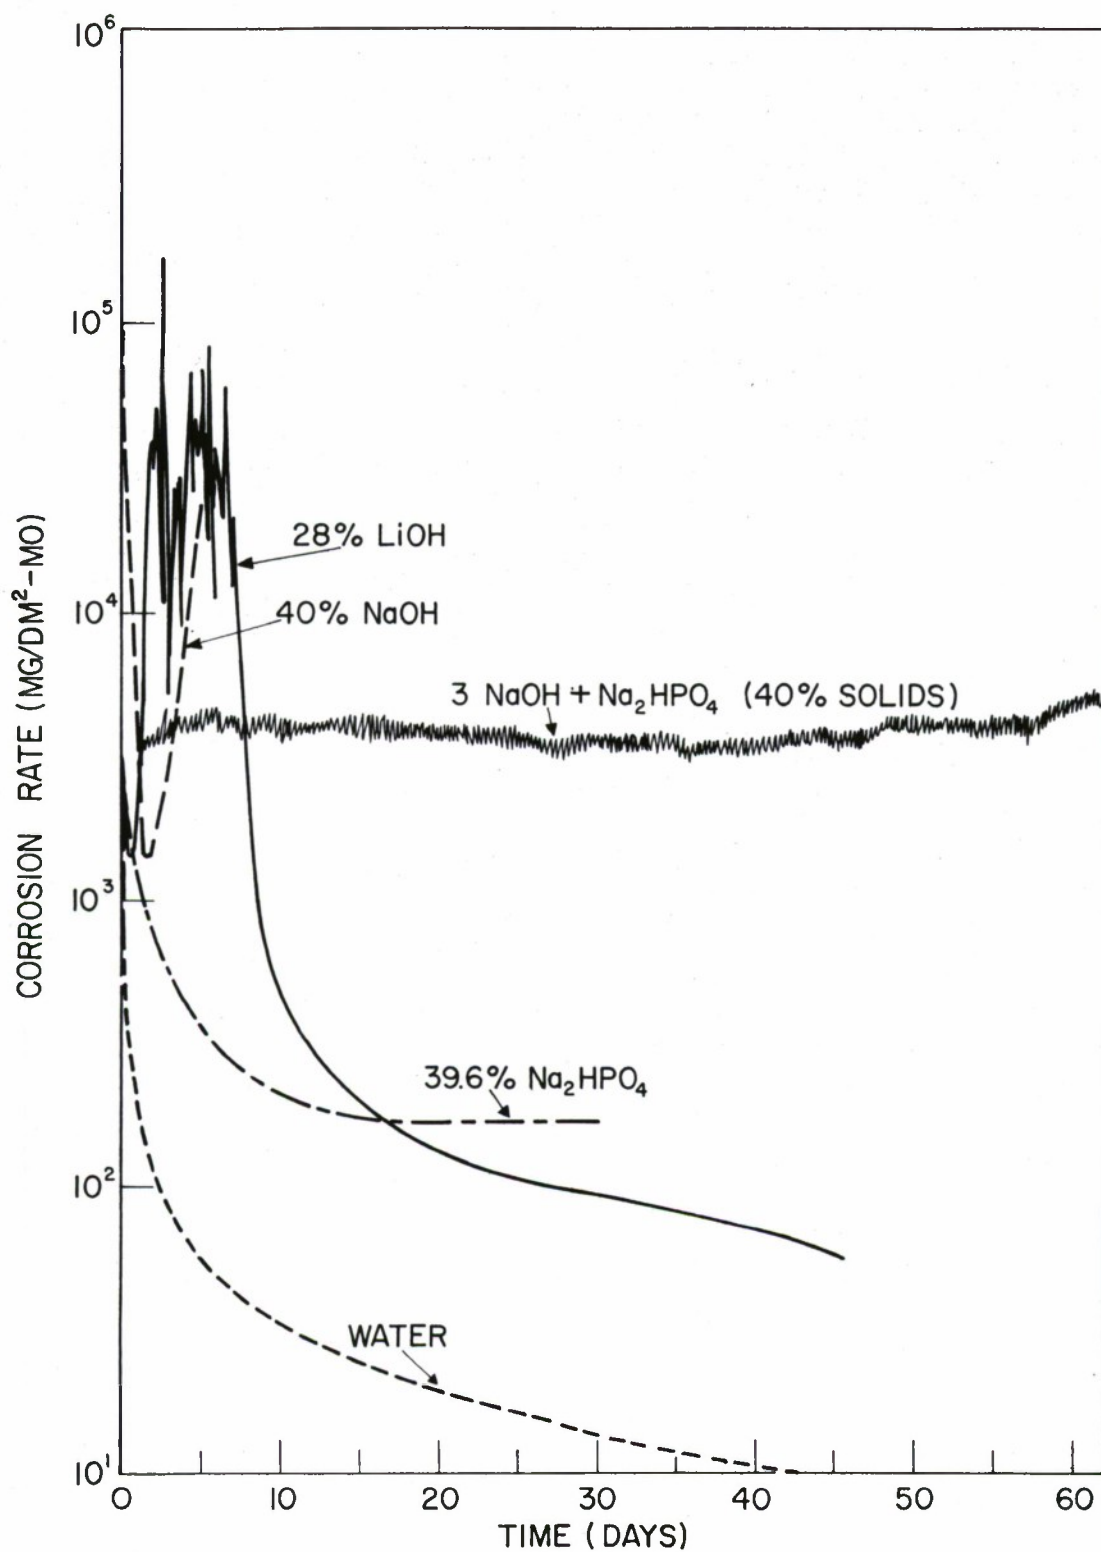
Fig. 12 - Corrosion rate of mild steel at 316°C (600°F)

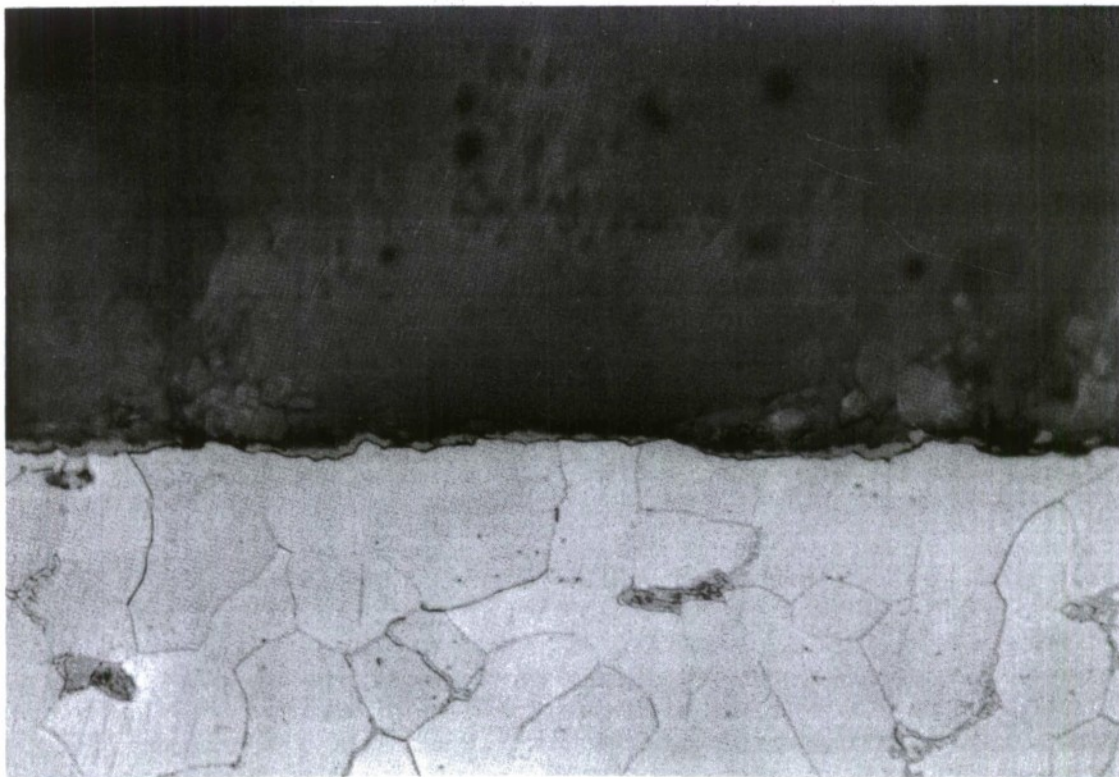
Fig. 13 - Section through inside surface of mild steel capsule filled with $\text{Na}_2\text{HPO}_4 \cdot 12 \text{H}_2\text{O}$ and maintained at 316°C for 30 days. 1% Nital. Magnification: 1000X. (Reduction in printing approximately 8%.)

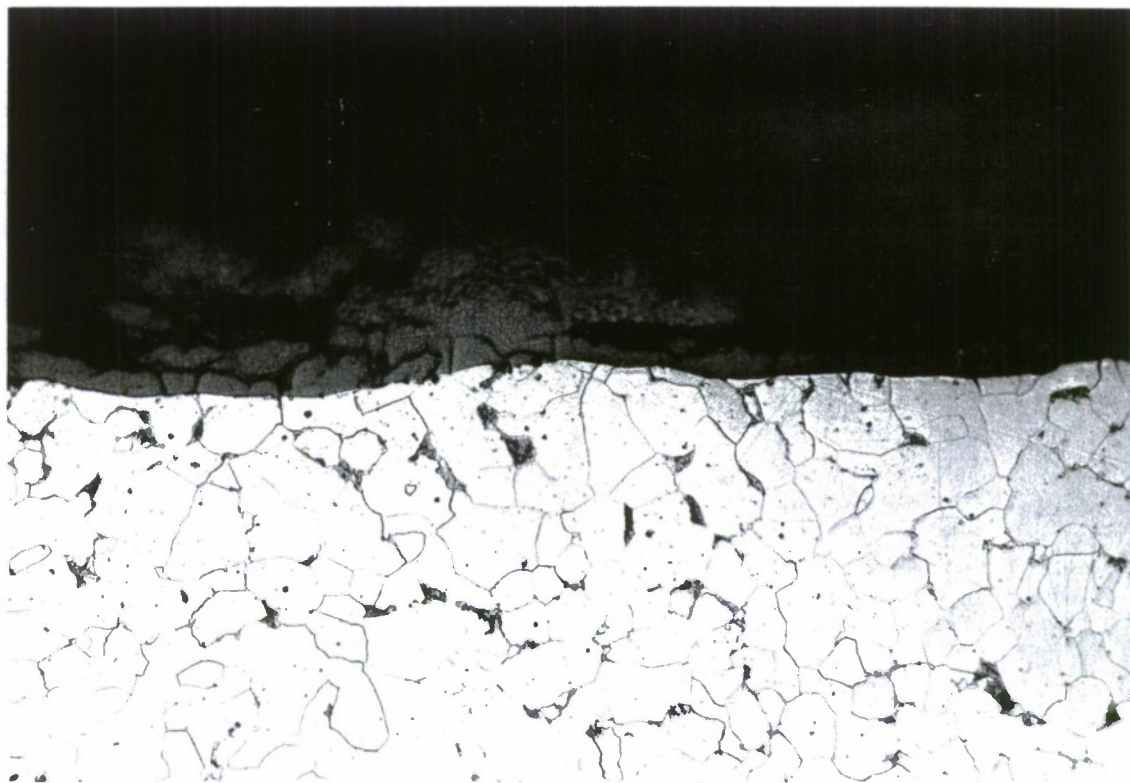
Fig 14 - Section through inside surface of mild steel capsule filled with NaOH and Na_2HPO_4 in the mol ratio 3:1, total solids = 40%, and maintained at 316°C for 30 days. 1% Nital. Magnification: 1000X. (Reduction in printing approximately 8%.)

Figure 14 shows the corrosion product generated on the surface of a capsule filled with the solution containing hydroxide and phosphate in the 3:1 mol ratio of NaOH/Na₂HPO₄. The corrosion product was found to be soft and relatively nonadherent. Clearly the picture is not yet complete.

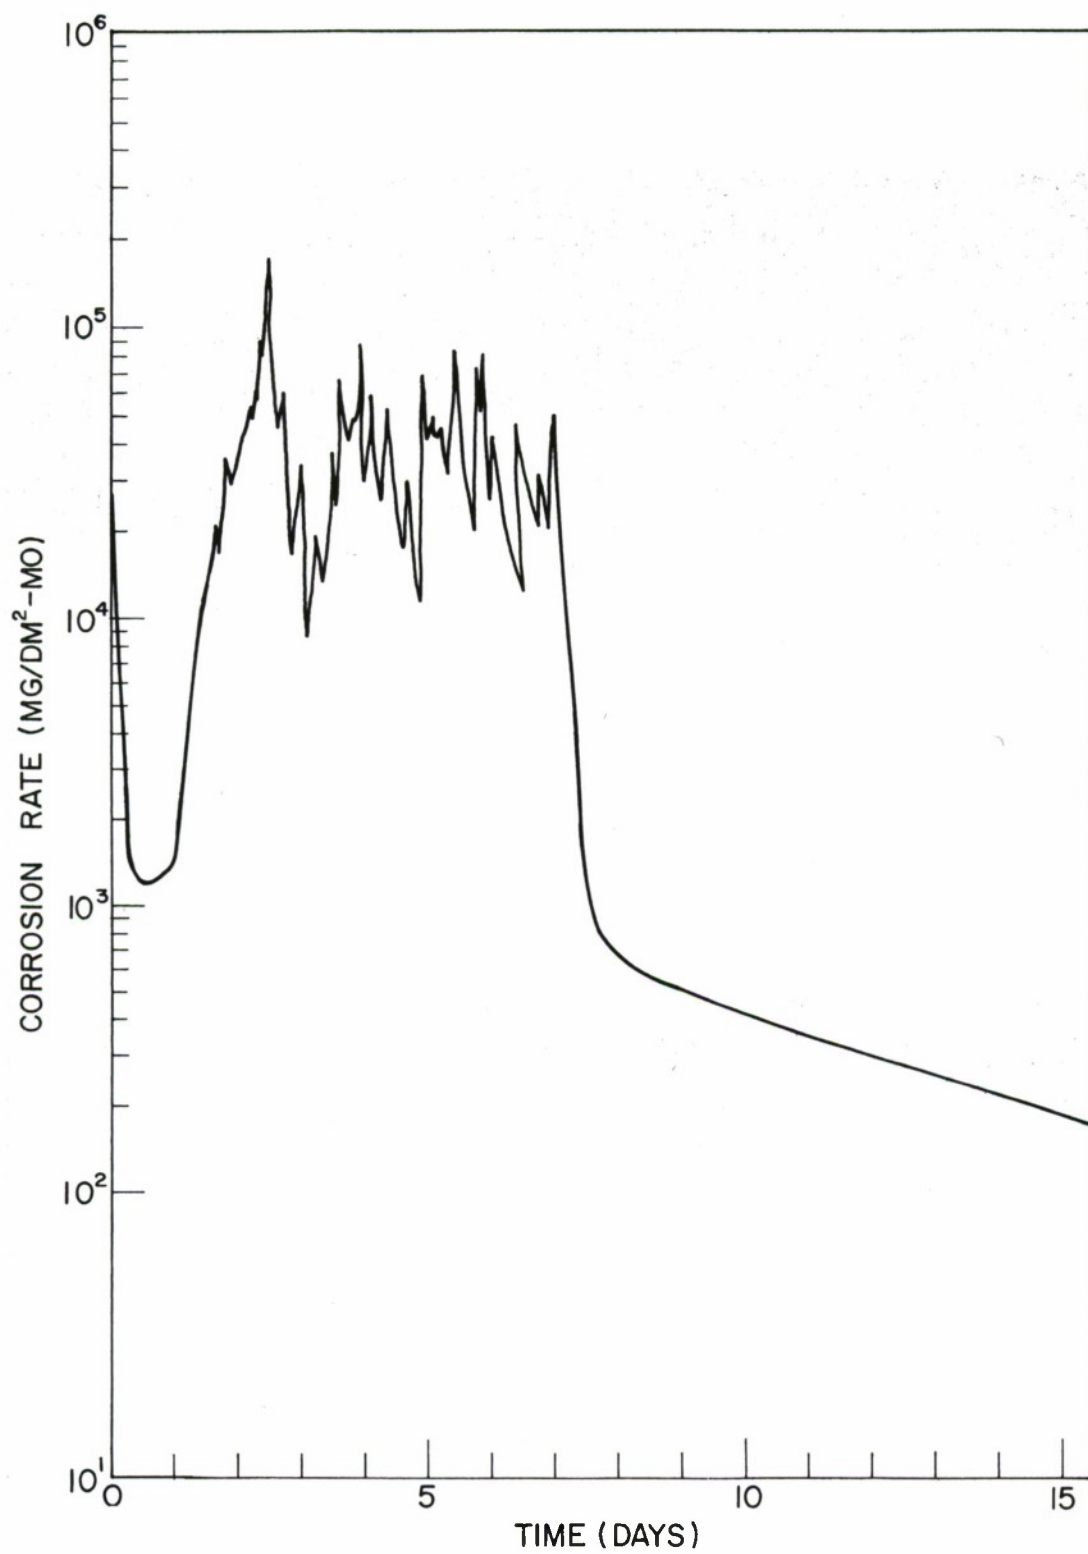
Fig. 15 - Corrosion rate of mild steel in 28% LiOH
at 316°C (600°F)

Figure 15 shows the LiOH corrosion rate vs. time curve on an expanded scale. Samples removed within the first 12 hours, before the rate starts to rise, show, as we might expect, the normal Fe₃O₄ film whose presence is causing the rate to drop. If, however, a sample is removed after the start of the rise, it is found that a new corrosion product is starting to form and gradually replacing the Fe₃O₄. Analysis shows this new corrosion product to be LiFeO₂ and it is not adherent. It appears that this new solid phase must form by the reaction

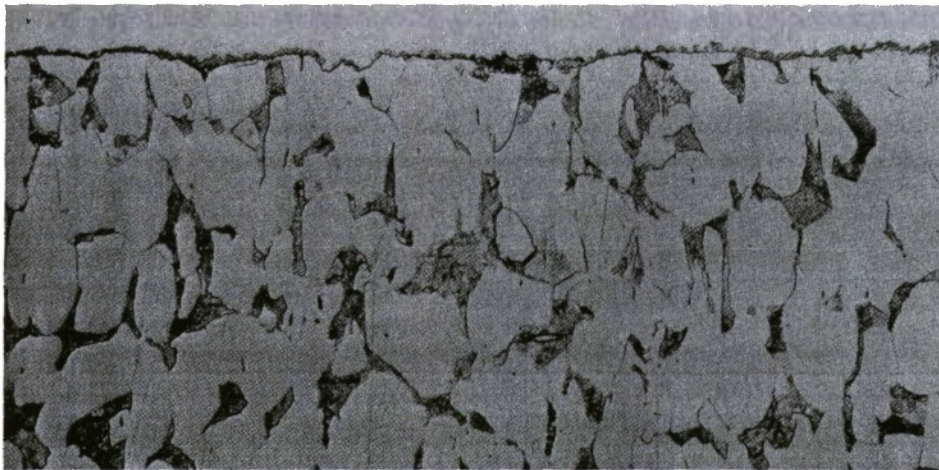
Fig. 16a - Section through bare steel area remote from cavity in specimen exposed to 600°F distilled water. Original magnification: 500X. (Reduction in printing approximately 20%.)

Figure 16 shows representative areas both outside and inside the cavities of specimens in which there is no evidence of accelerated corrosion attack within the cavity.

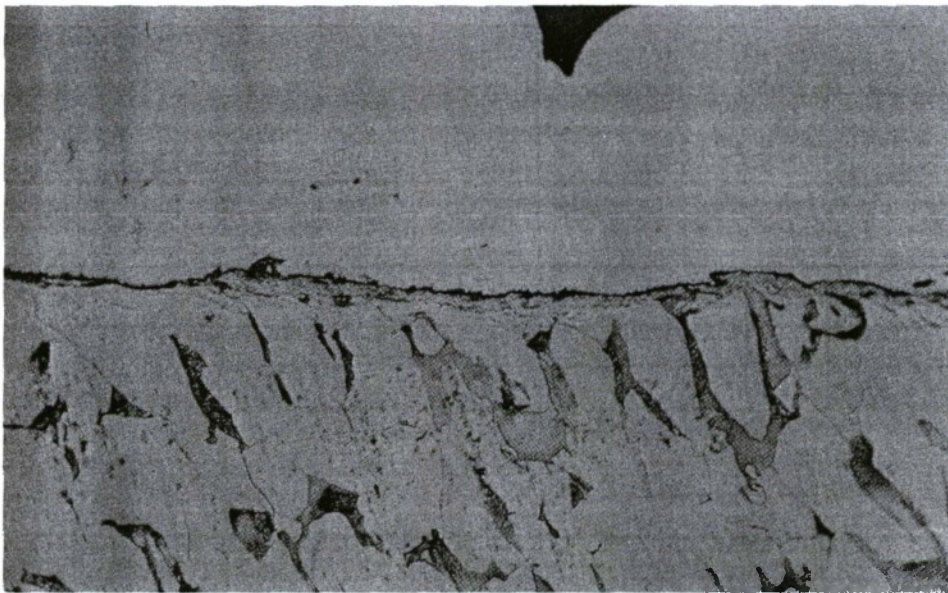
Fig. 16b - Section through area within the Fe_3O_4 filled cavity in the specimen in Fig. 16a. Original magnification: 500X. (Reduction in printing approximately 20%.)

Characteristic of the first type of specimen are the visible traces of cold working during the drilling operation in Fig. 16b and the absence of such traces in

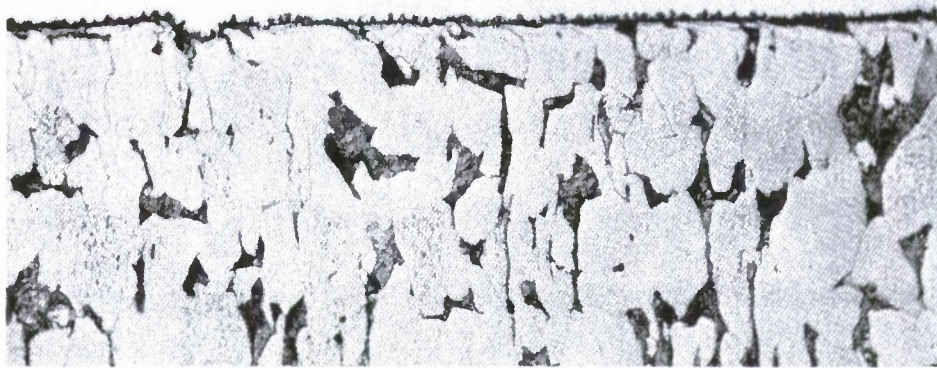
Fig. 17a - Section of bare steel area remote from the cavity in specimen exposed to 600°F, 4% H₂O₂ for 4 weeks. Original magnification: 500X. (Reduction in printing approximately 20%.)

Figure 17 shows representative areas of specimens in which corrosive attack has definitely been greatly accelerated within the cavity and again shows areas both outside and inside the cavity.

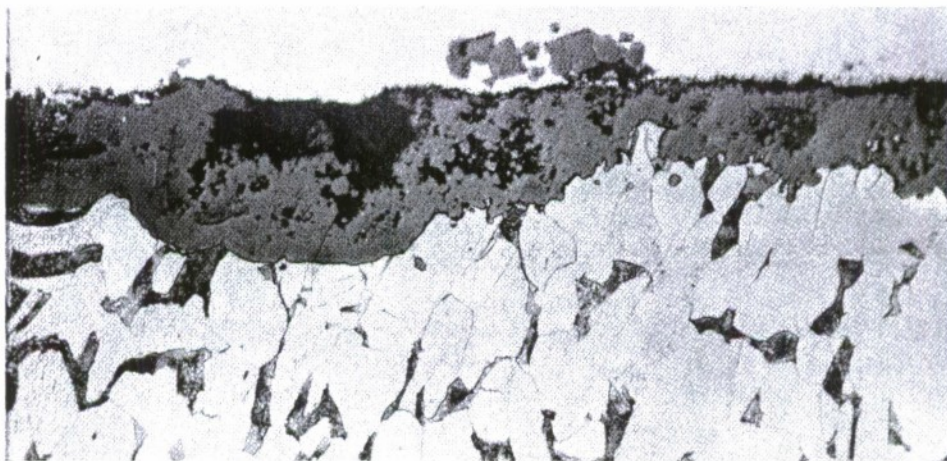
Fig. 17b - Section through area within the Fe₃O₄ filled cavity in the specimen in Fig. 17a. Original magnification: 500X. (Reduction in printing approximately 20%.)

Fig. 17b, where the accelerated corrosion has destroyed the metal of the original cold-worked surface.

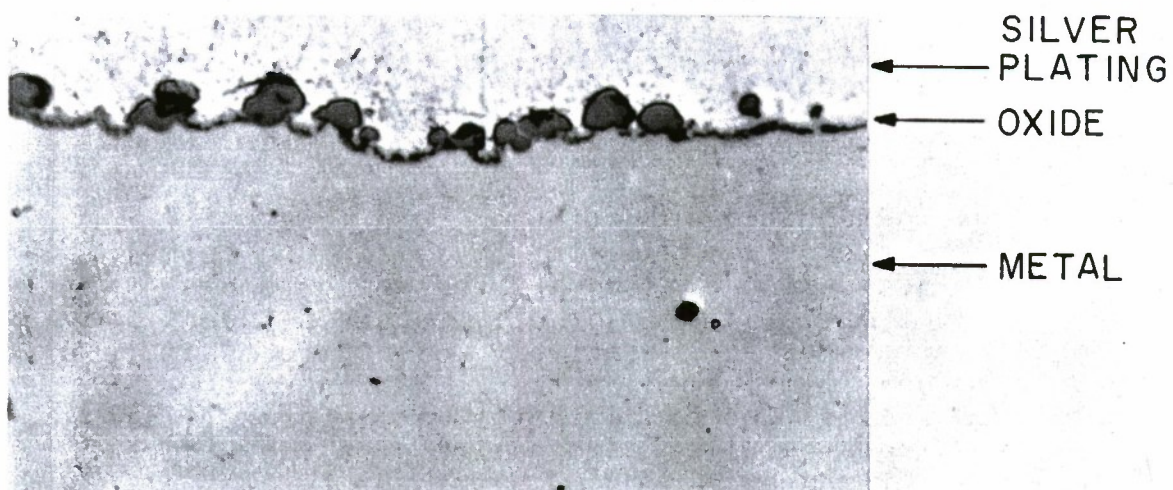
Fig. 18 - Spinel film formed on mild steel exposed to distilled water at 600°F for 6 weeks. Magnification: 1000X. (Reduction in printing approximately 6%.)

Metallographic examination of both types of specimens (after silver plating to retain the spinel film in place during cutting and polishing) shows clearly that one of the major differences between the two is the thicker and relatively more uniform nature of the spinel film formed on the LiOH-treated steel (Figs. 18 & 19). The oxide in the water-formed film appears to be a peculiar combination of a very thin continuous film overlaid by much thicker "blobs" or "boulders", the thickness of the latter being of the same order of magnitude as that of the film formed on the LiOH-treated steel. Solution of the spinel film in hydrochloric acid and flame spectrophotometry of the resultant solution has shown that the film formed by the LiOH treatment contains somewhat more than 0.4 atomic percent $\left(\frac{\text{Li}}{\text{Li} + \text{Fe}} \times 100 \right)$ of lithium.

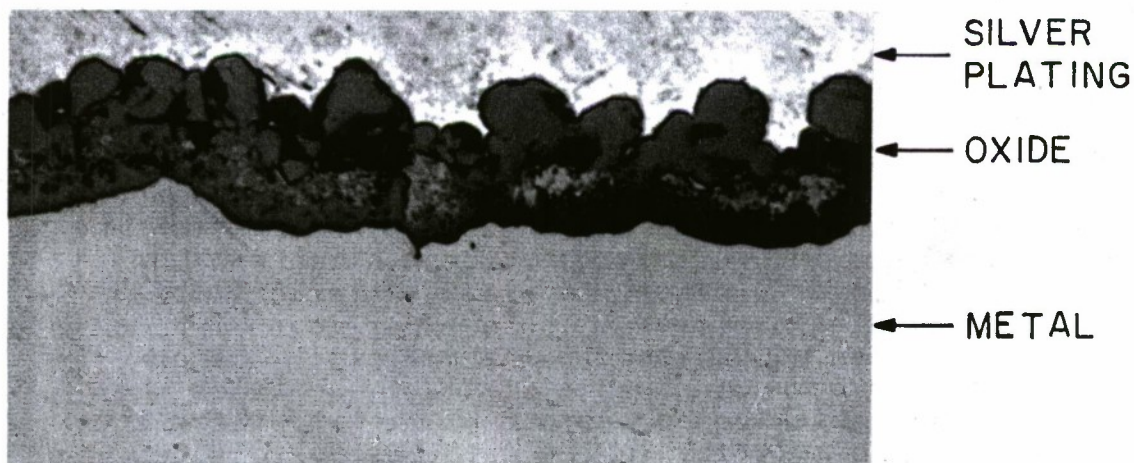
Fig. 19 - Spinel film formed on mild steel exposed to 0.1 molar LiOH at 600°F for 6 weeks. Magnification: 1000X. (Reduction in printing approximately 6%.)
